SWST - International  
Society of Wood  
Science and Technology

# A Visual Assessment of Cross-laminated Timber Structures in Austria

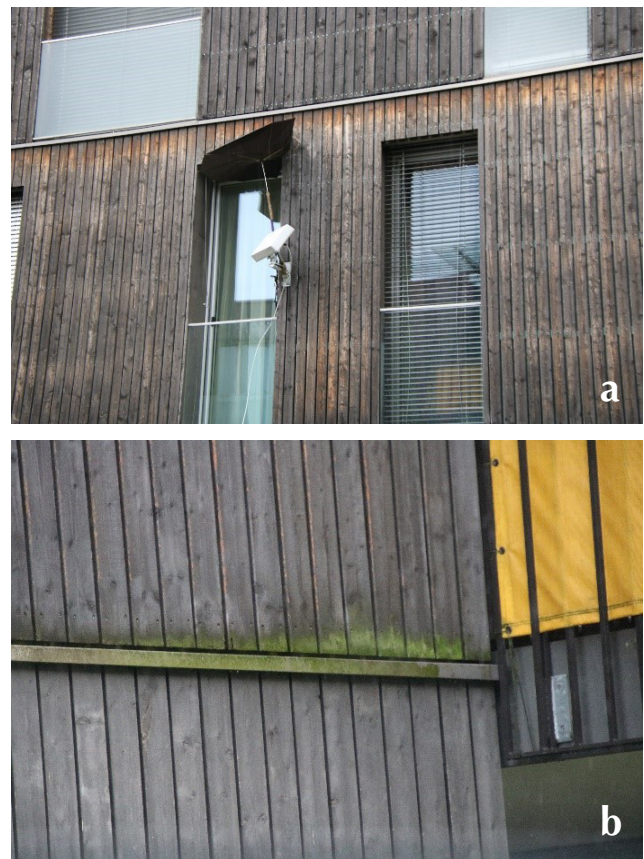
A relatively small amount of deterioration was observed due to green staining in some parts of the siding on the exterior parts of the buildings. The siding showed heavy discoloration due to exposure to ultraviolet light (see Figure 1). The siding was close to the ground and did not have protective flashing to avoid rain splash contacting the siding.

Figure 1. Direct exposure to sunlight and moisture accumulation on siding leading to (a) discoloration and (b) blue, black, or green staining.

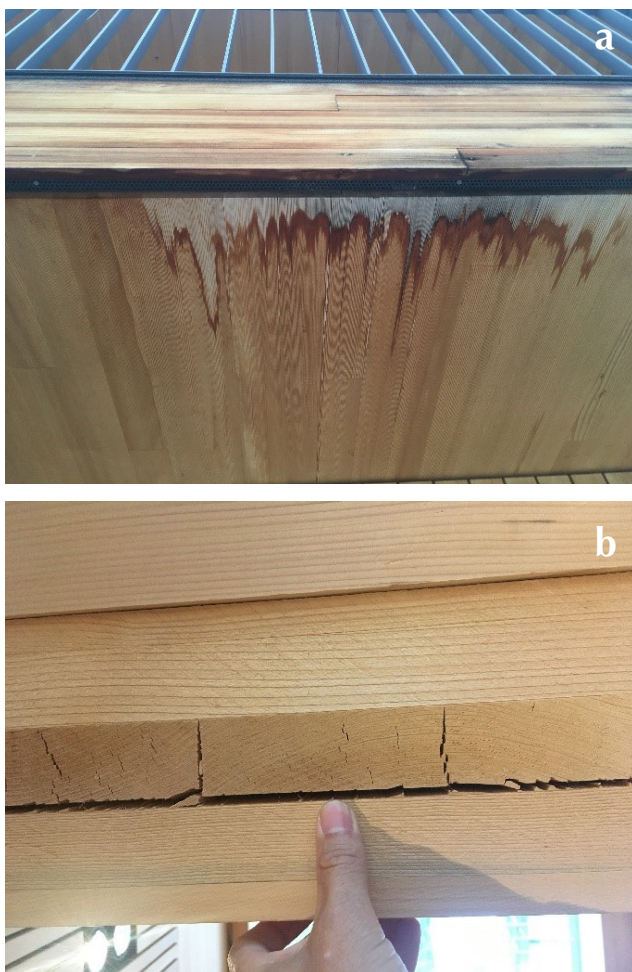
The wood siding showed sunlight damage and gray or black staining. The inspection did not find any evidence of decay on the exterior side of the CLT walls, but evidence of water damage was found in the balconies. Figure 2a shows discoloration that was visible on the exterior and interior surfaces of the siding and CLT panels, especially beneath the balconies. The water damage found in the balconies could have been prevented by adding appropriate flashing, to minimize water penetration into the end grain of the wood in the CLT panels. Figure 2b also shows some delamination of the interior

Figure 2. (a) Exterior signs of discoloration in the CLT balcony; (b) interior checking of CLT panels.

CLT panels, likely caused by cyclic changes in the humidity of the internal environment of the building.

The tenants of building B were pleased with the overall performance of the structure. The building is 7 years old, and there have not been any major structural or serviceability issues. The building is very quiet and pleasant, but the tenants reported that it tended to get very hot in summer because the large glass windows collected the warmth of the sun. This could be causing low relative humidity in the interior, leading to delamination and wood splitting, as seen in Figure 2b.

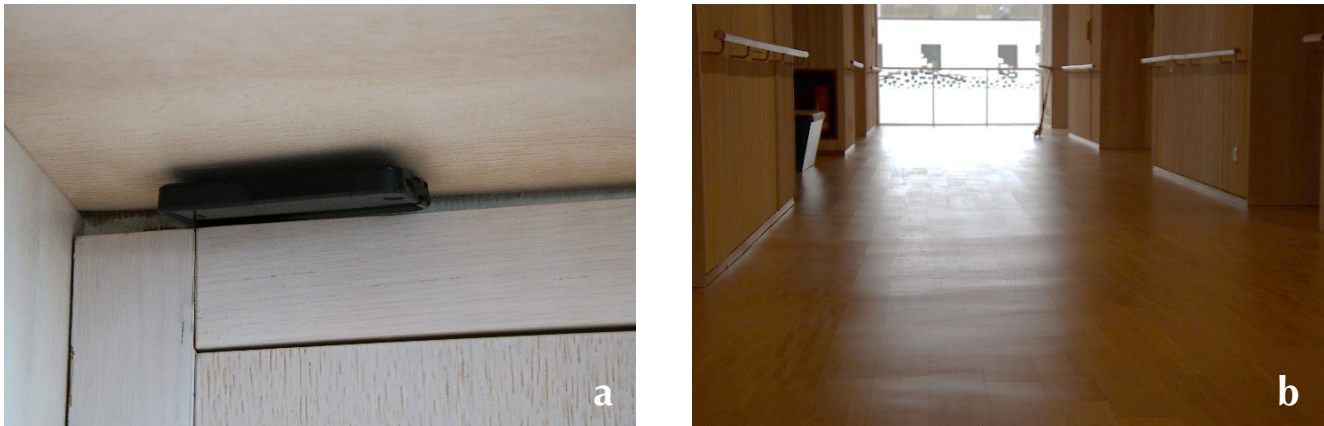
The interior of the building had evidence of shrinkage and swelling of the wood. There were gaps between panels, splits in the CLT surfaces, and gaps near the openings around windows, doors, and walls. These issues were likely caused by the accumulated shrinkage and swelling of the overall system. The architect pointed out that the structural integrity of the building was not compromised.

The issues were more evident in the upper floors, as the impact of the movement of wood, due to the absorption and release of moisture, accumulated. The image in Figure 3a shows a black cell phone inserted into a 12 mm gap between a door frame and the ceiling. Figure 3b shows a pronounced wave in the surface of the floor system.

Figure 3. (a) A gap between a door and the ceiling; (b) ceiling and floor showing waving in the fifth floor due to the impact of accumulated shrinkage and swelling of CLT boxes.

vertical direction, which was magnified by the height of the fourth floor. This caused some visible gaps, and interference, and binding when closing and opening doors.

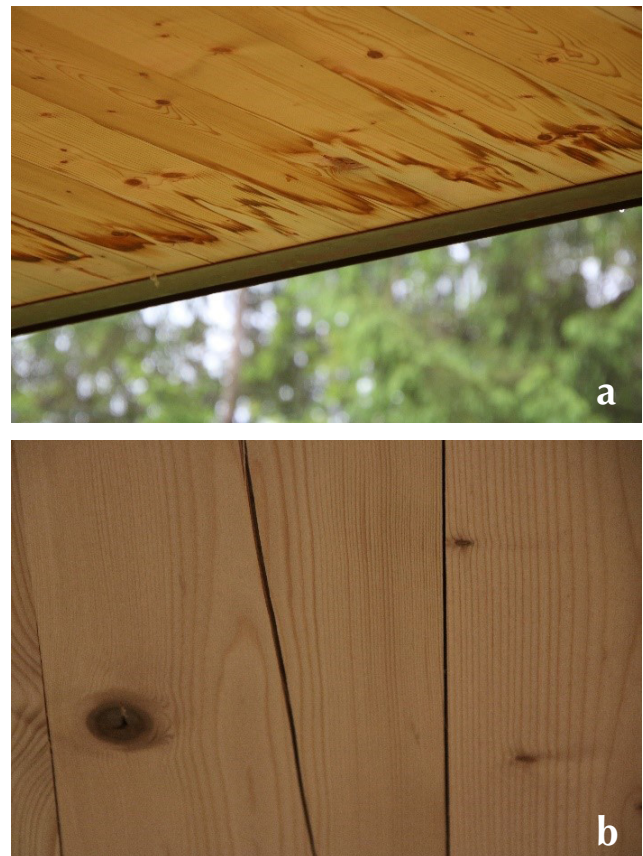
Inside the building there was some visible damage related to changes in moisture content of the building interior. Splitting and separation of the CLT lamellas was noticeable (see Figure 4b) in several sections of the ceiling/flooring CLT panel system. The CLT panels were fabricated by gluing only the face side of the lamellas and not the edge.

Figure 4. (a) Damage caused by exposure to moisture into the end grain of the CLT panels near the bottom of the overhangs; (b) splits in the surfaces of the CLT panels caused by changes in equilibrium moisture content inside the building.

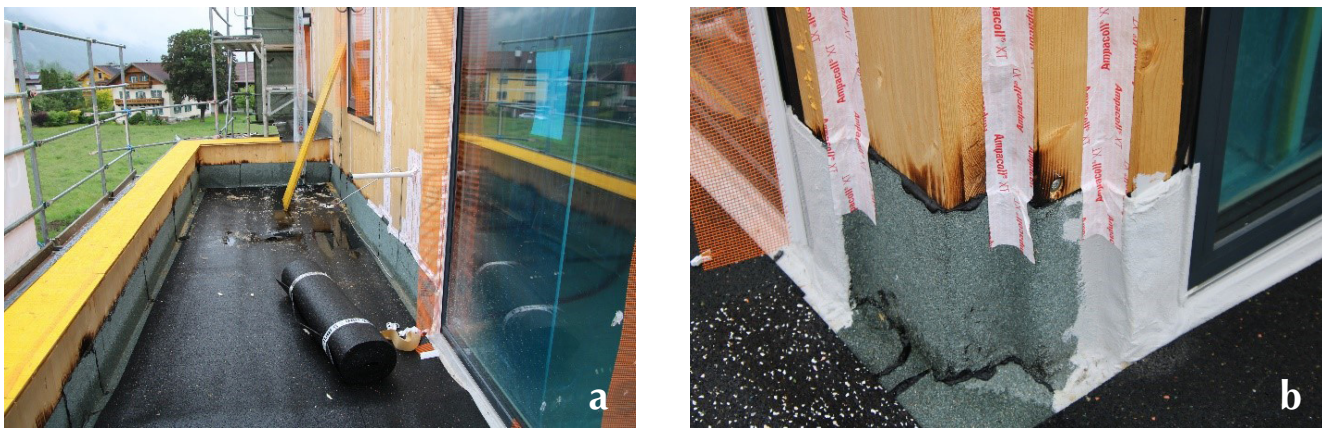
The balconies were part of the ceiling/floor structure. Flashing material was used to protect the CLT panels from water and moisture, as shown in Figure 7a. However, some signs of staining were visible, as seen in in Figure 7b.

Figure 7. (a) Flashing used in balconies; (b) visible damage caused by water exposure in balconies.
