SWST - International  
Society of Wood  
Science and Technology

# A Visual Assessment of Cross-laminated Timber Structures in Austria

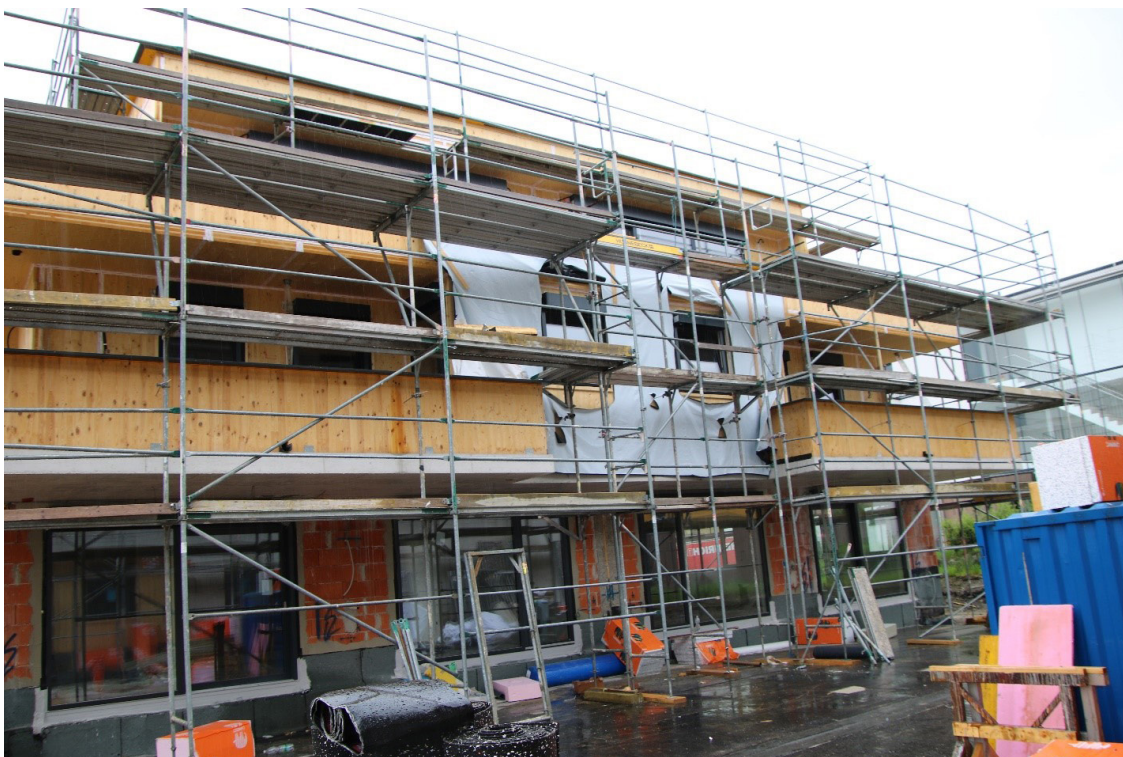
Figure 5. Exterior view of apartment complex, Building F.

The area of the new project is 600 m<sup>2</sup> for eight flats on three stories. CLT panels were used for the wall and the ceiling/floor systems. The project included underground parking and a concrete elevator shaft. Figure 5 shows a view of the exterior, still under construction.

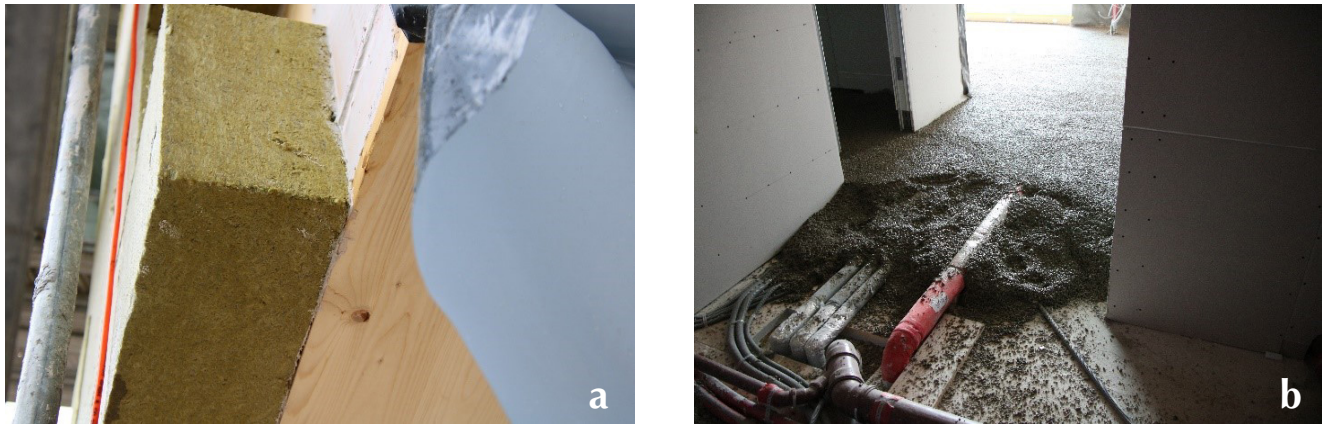
The thickness of the CLT panels used in the floor system was 24 cm. All ducts for utilities were run on top of the floor CLT panels. A 20 cm layer of lightweight concrete was poured on top of the utilities to cover and protect them. Additionally, the concrete layer contributed to noise abatement and to strengthen the floor structure (see Figure 6a).

The internal CLT walls were covered with gypsum wallboard in most of zones. The architect decided not to have the CLT wall panels exposed. This was a visual and aesthetic decision. The gypsum wall coverings can be seen in Figure 6a. Insulation was added to the external face of the wall CLT panels, as shown in Figure 6b. The insulation was painted after installation to prevent or slow down potential damage from exposure to water.

Figure 6. (a) Light-weight concrete being poured on the CLT floor system; (b) insulation added to the exterior CLT wall.
